STUDY OF CLAY SHALE SLOPES

MISCELLANEOUS PAPER S-71-22

D. C. Banks

October 1971

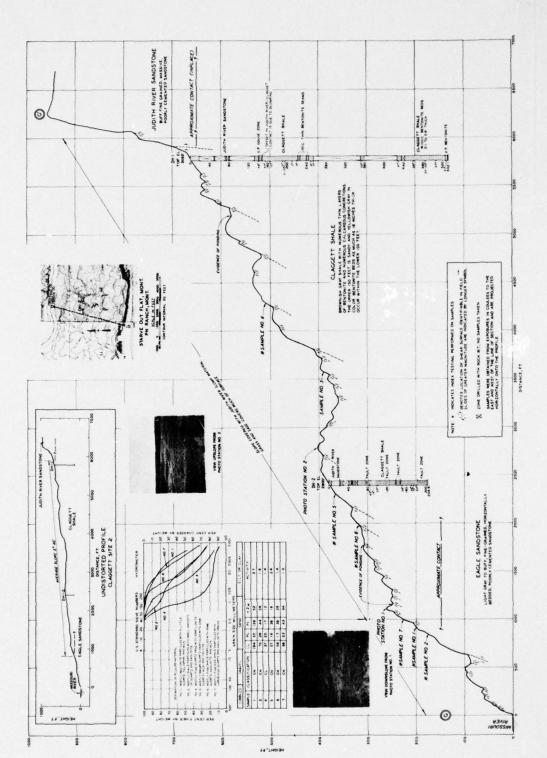
and while overall slope heights amounted to several hundred feet, inclinations were typically very low (5 to 10 deg), for example, Fig. 2. Excavations into these materials have usually exposed old failure surfaces, on which renewed sliding occurred. Slickensides were especially common in these three materials. Cementation was minimal, with the exception of parts of the Pierre. Slope inclinations in these three materials are comparable to their residual angles of internal friction. Where the Judith River sandstone formed a rigid base, certain slopes in the Bearpaw stood slightly steeper than elsewhere. Slope failures in the Colorado group, also a marine deposit of Late Cretaceous age, were relatively uncommon. Where they occurred, sliding appeared to involve a single failure, for example Fig. 3. Cementation was fairly well developed in the Colorado group; and probably as a result thereof, slope inclinations in the unit commonly were steeper than the residual angle of internal friction of the materials. Slickensides were present but not common. The Paleocene (lowermost Tertiary) Fort Union group, composed of one marine and two nonmarine formations, generally stood less steeply and showed more failures than the Colorado group, but stood steeper with fewer failures than the Claggett, Bearpaw, and Pierre formations. Notably, there were wide intraformational as well as the interformational differences within each of the five geologic units studied. Bentonitic layers with high plasticity characteristics, high swelling potential, and low residual shear strength were found in all of the units.

Fig. 2. Claggett site 2, geologic section G-G'.

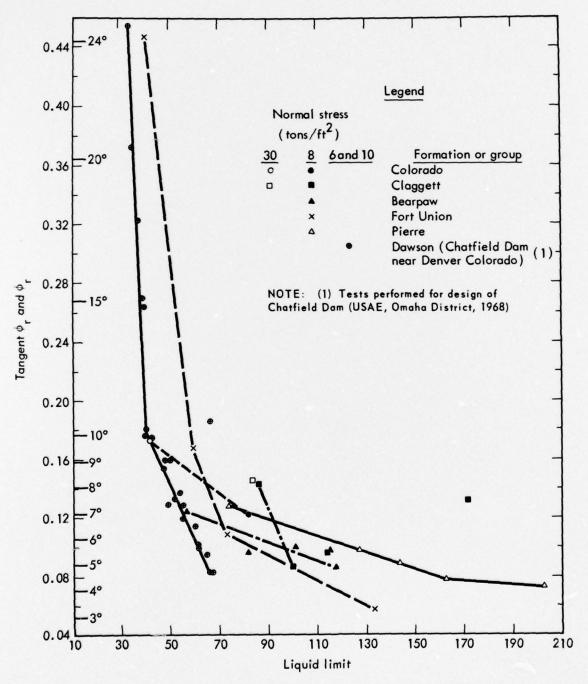
showed considerable overlap. The tests indicated a highly anisotropic character to the swell-shrinkage behavior of the clay shales. In particular, the swell pressure measured parallel to bedding was less than the swell pressure perpendicular to bedding; additionally, shrinkage of specimens was less than that measured parallel to bedding than perpendicular. The effects of surface weathering and erosion were illustrated by the decrease in shrinkage with depth and an increase in the swell pressure. The effect of depth was also noted from consolidation tests in that shallow specimens exhibited steeper consolidation curves than the deeper. Since there was almost as large a range in measured properties within a formation as between formations, it appeared that only gross differences in slope behavior could, in this study, be related to any specific test or series of tests. This conclusion was especially true since the slopes under consideration were all natural, geologically old slopes, and had therefore been subjected to the various factors discussed previously for many thousands of years. Since the overall slopes were generally failed, the residual strength of the materials was important, Fig. 4.

Fig. 4. Summary of residual direct shear test data.

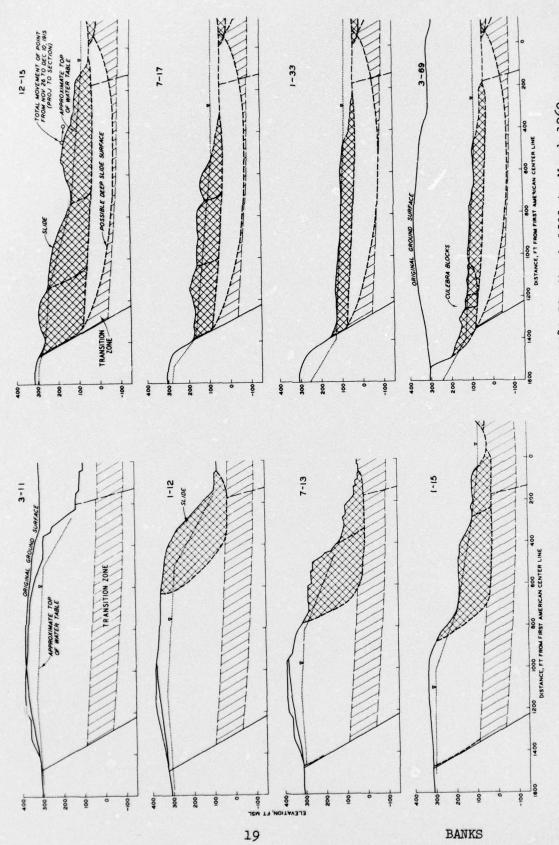
Sliding activity accelerated on the east side to a major break in 1914 almost a year after the canal was flooded for dredging. By January 1915, the West Culebra slide was divided by long cracks along geological fractures into several potentially unstable blocks. The blocks evolved to graben and horst structures as the mass crept slowly canalward. In August and September 1915, both slides converged in massive failures accompanied by upheaval of the canal bottom and blockage of the canal. An example of the reconstructed history of sliding for one section in the East Culebra slide is shown in Fig. 11.

Fig. 11. Development of East Culebra slide at sta 1782+50, March 1911 to March 1969.

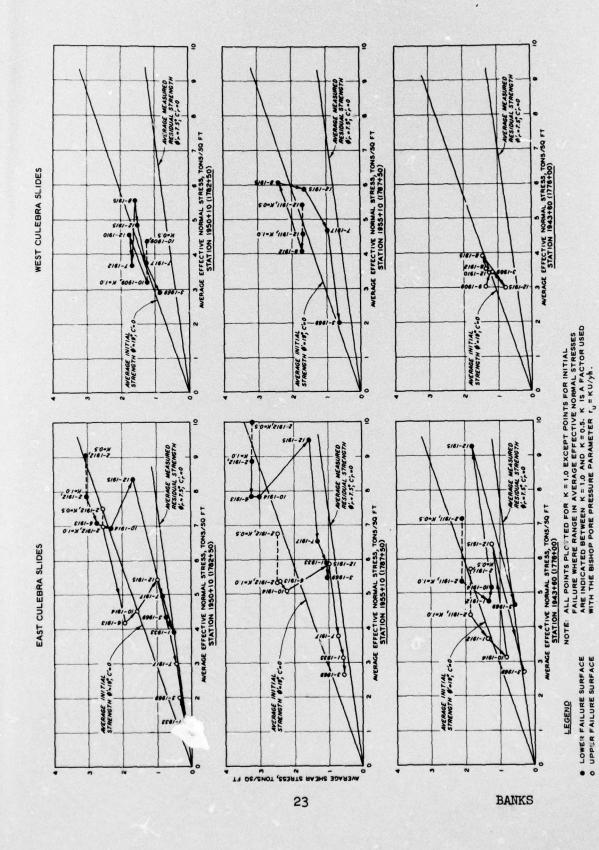
Average stresses from analyses of East and West Culebra slides. Fig. 12.

slide) remained high and near the strength envelope determined for initial failure despite the large movements that occurred. Analyses of failure conditions subsequent to the time of massive movements to the present indicate a large reduction in required shear strength (Fig. 12). In most cases the required shear strength was slightly higher than the average residual strength from laboratory tests. This is consistent with continued slope movements occurring in the East Culebra and West Culebra slides.
